**CENTER FOR MARINE RESOURCES AND ENVIRONMENTAL
TECHNOLOGY and SEABED TECHNOLOGY REASERCH CENTER
UNIVERSITY OF MISSISSIPPI**

Activities Report for Cruise GOM2-08-MC118 aboard the *R/V Pelican*
Integrated Data/Power Unit and Data Recovery System Deployment Cruise
Mississippi Canyon Federal Lease Block 118,
Northern Gulf of Mexico
May 31 to June 10, 2008
by
Ken Sleeper¹

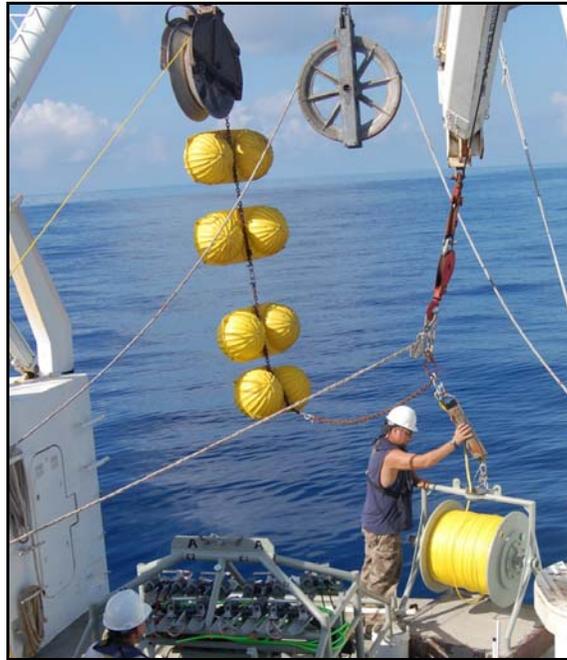
Figure 4. The Popup Buoy ready for deployment off the stern of the *Pelican*. At the base of the buoy is a cement weight to hold the assembly on the seafloor. Above the weight is a spool of ultrax rope (yellow drum) connected to an acoustic release. The release is anchored to the buoy below and a series of floats above (yellow hard hats). To retrieve the fiber optic cable from the IDP the acoustic release is triggered allowing the floats to rise while pulling the length of ultrax behind. Once surfaced, the floats can be retrieved and the ultrax rewound on board which brings the buoy and the attached fiber optic cable to the surface.

On the morning of June 1st we arrived on site at MC118 and conducted the pop-up buoy test (Fig 4). For this test, only the buoy was sent to the seafloor and, once there, the acoustic releases were triggered to allow the floats to draw the Ultrax fiber rope to the surface. When the floats surfaced, the line was connected to the Institute's hydraulic winch and the buoy was retrieved from the seafloor. The test was a success, the line un-spooled as designed and the floats had more than enough buoyancy to keep the line from tangling. A mooring was subsequently deployed for calibrating the USBL system and recovered upon completion. One final flotation test was also made on a recoverable USBL transponder unit. This unit was designed to mount on or near the IDP to help guide the IDP during installation. After placement, the transponder would be recovered via a special release mechanism and float jacket developed to help prevent entanglement in the cables. The test was successful and activities turned toward the actual deployment of the components.

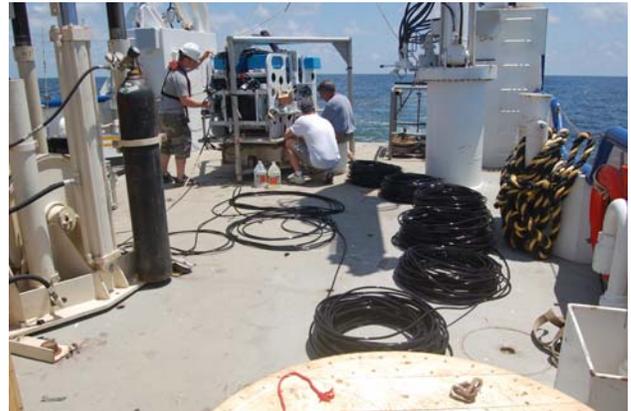
Figure 7. Array cable coiled on the deck of the *Pelican*.

To conduct the survey an electronics package was mounted on the front of the SSD and an electrode array was attached to the aft of the landing cage (Fig. 6 and 7). The SSD provides a smart tow-body with a high-speed communications link to the system, obstacles avoidance sonar, pressure transducer for array altitude and cameras with lighting for visual inspection of bottom conditions. The array itself consists of a 570m cable with 28 electrodes that trails the SSD making contact with the sea floor while the system is pulled slowly along by the ship. The array was designed with an expected penetration of 180m with 10m resolution.

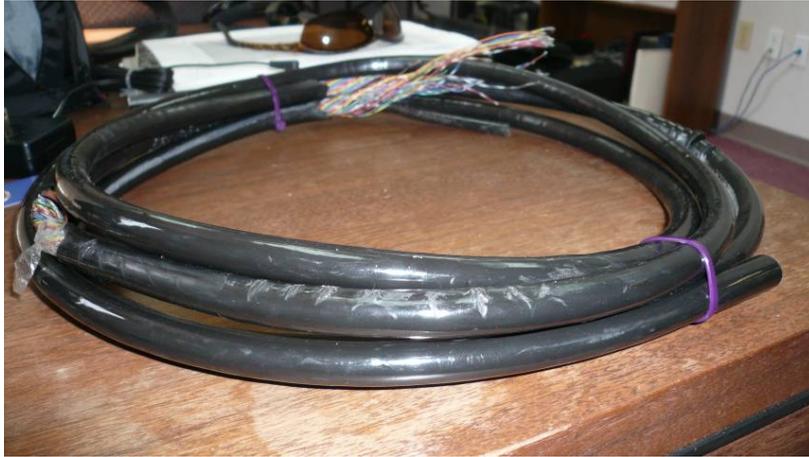
Figure 8. A damaged section of the resistivity array cable with bite marks, damaged jacket, and frayed wires.

backup cable for another application. During replacement of this cable the resistivity array streamed behind the vessel at near surface depths. When the SSD was re-deployed to the seafloor and the resistivity system powered up a fault was immediately detected in the resistivity electronics package. Upon retrieval it was discovered that the last 200 meters of the array with 10 electrodes were missing. The end of the array was mauled and showed bite marks consistent with those of a shark (Fig. 8). Additional details on the operations of the resistivity survey are presented in Appendix 1.

At 9:30 PM the process of retrieving the SSD was begun and at 10:30 the SSD and resistivity system were back on the deck. At this point, the damage assessment began. First, the electrode array had been severed. The active part of the electrode array that had been 540 m long with 28 electrodes, ended at 360 m, at the 18th electrode. Ten electrodes and 200 m of cable were missing. The severed end of the cable showed bite marks and areas where the cable jacket had been torn and chewed. Apparently, the cable was bitten off by sharks, perhaps during the 2 hr period in which it was trailing the ship in near the surface, while the mid-water weight was removed.
